Causes and Solution to Correct the Misalignment of the Ceramic Dome and Base

September 1, 2015

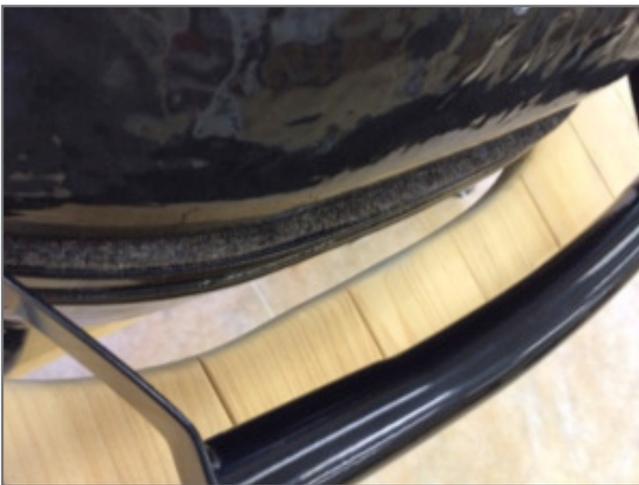
“Front to Back” misalignment can occur when the dome has moved toward the spring-assisted hinge and the front edge of the base is visible. It appears as an “under bite”. This is a result of one or more of the bands has become loose. Another occurrence is when the dome moves away from the spring-assisted hinge and extends beyond the edge of base edge. It appears as an “over bite”. This is a result of multiple hinge plate cap nuts becoming loose.

Photo of “Front to Back” Misalignment (under bite).

1. Use two zip ties to prevent the spring-assisted hinge from applying pressure to the bands.
2. Try moving the dome into alignment. If you are able to align it, you may only need to tighten the eight cap nuts that attach the hinge to the bands.

3. Loosen the two band bolt nuts until they can be loosened with your fingers.
4. Position the dome so it is realigned with the base.
5. Tighten the base band enough so you can reposition it to be parallel to the edge of the base.
6. Tighten the dome band enough so you can reposition it to be parallel to the edge of the dome.
7. Rotate the tightening of each band with 4-5 turns each. The band bolt nuts should be very tight.
8. Check the hinge plate cap nuts for tightness. They should be snug. Do not over tighten.
9. Cut the zip ties and open the dome. Check that the dome and base are aligned properly.
10. After your first use, recheck the band bolt nuts and hinge plate cap nuts for proper tightness, then check periodically to maintain the proper alignment.

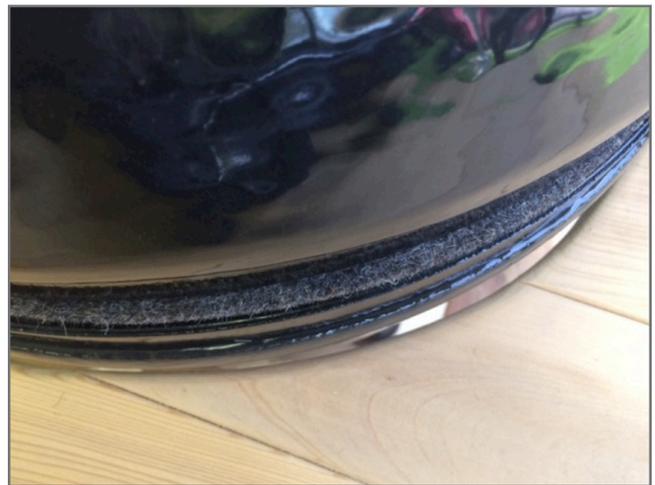
“Left to Right” misalignment means the dome has moved to the left or right exposing one of the edges of the side of the base. Typically, one or more of the band bolt nuts is loose, allowing the spring-assisted hinge to pull the dome out of alignment.

Photo of “Left to Right” Misalignment.

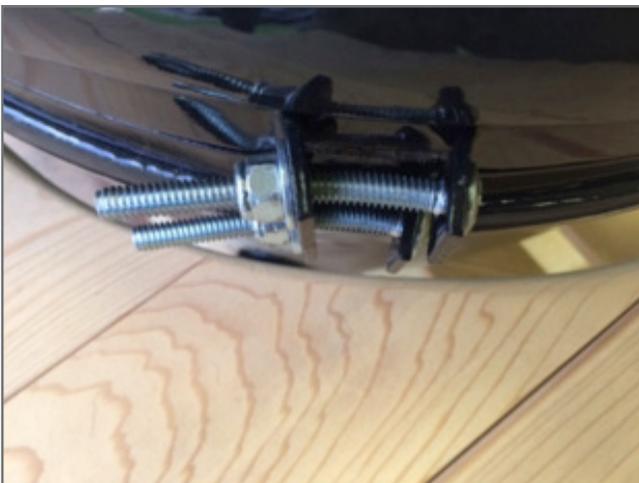
Photo of band bolts and nuts.

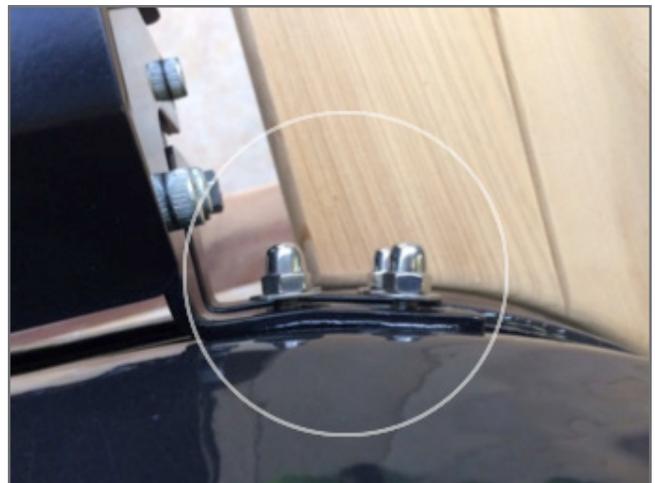
Photo of hinge plate cap nuts.

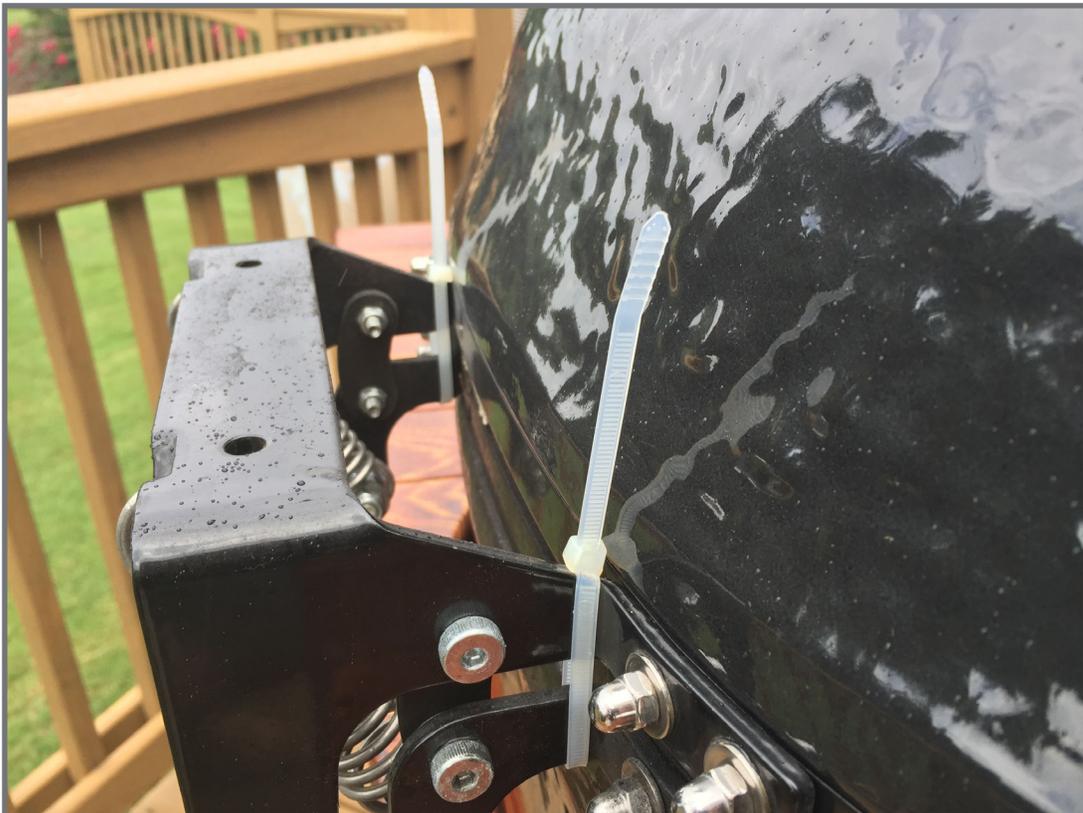
Photo showing the proper application of zip ties in step 1.
